Title Hydrology of the valley mire

**HIGH-LEVEL ASSESSMENT OF THE  
HYDROLOGY OF AN AREA OF VALLEY MIRE**

**CAER GLAW QUARRY**

**Report Reference: 3298/HLA  
Final version F1  
March 2022**

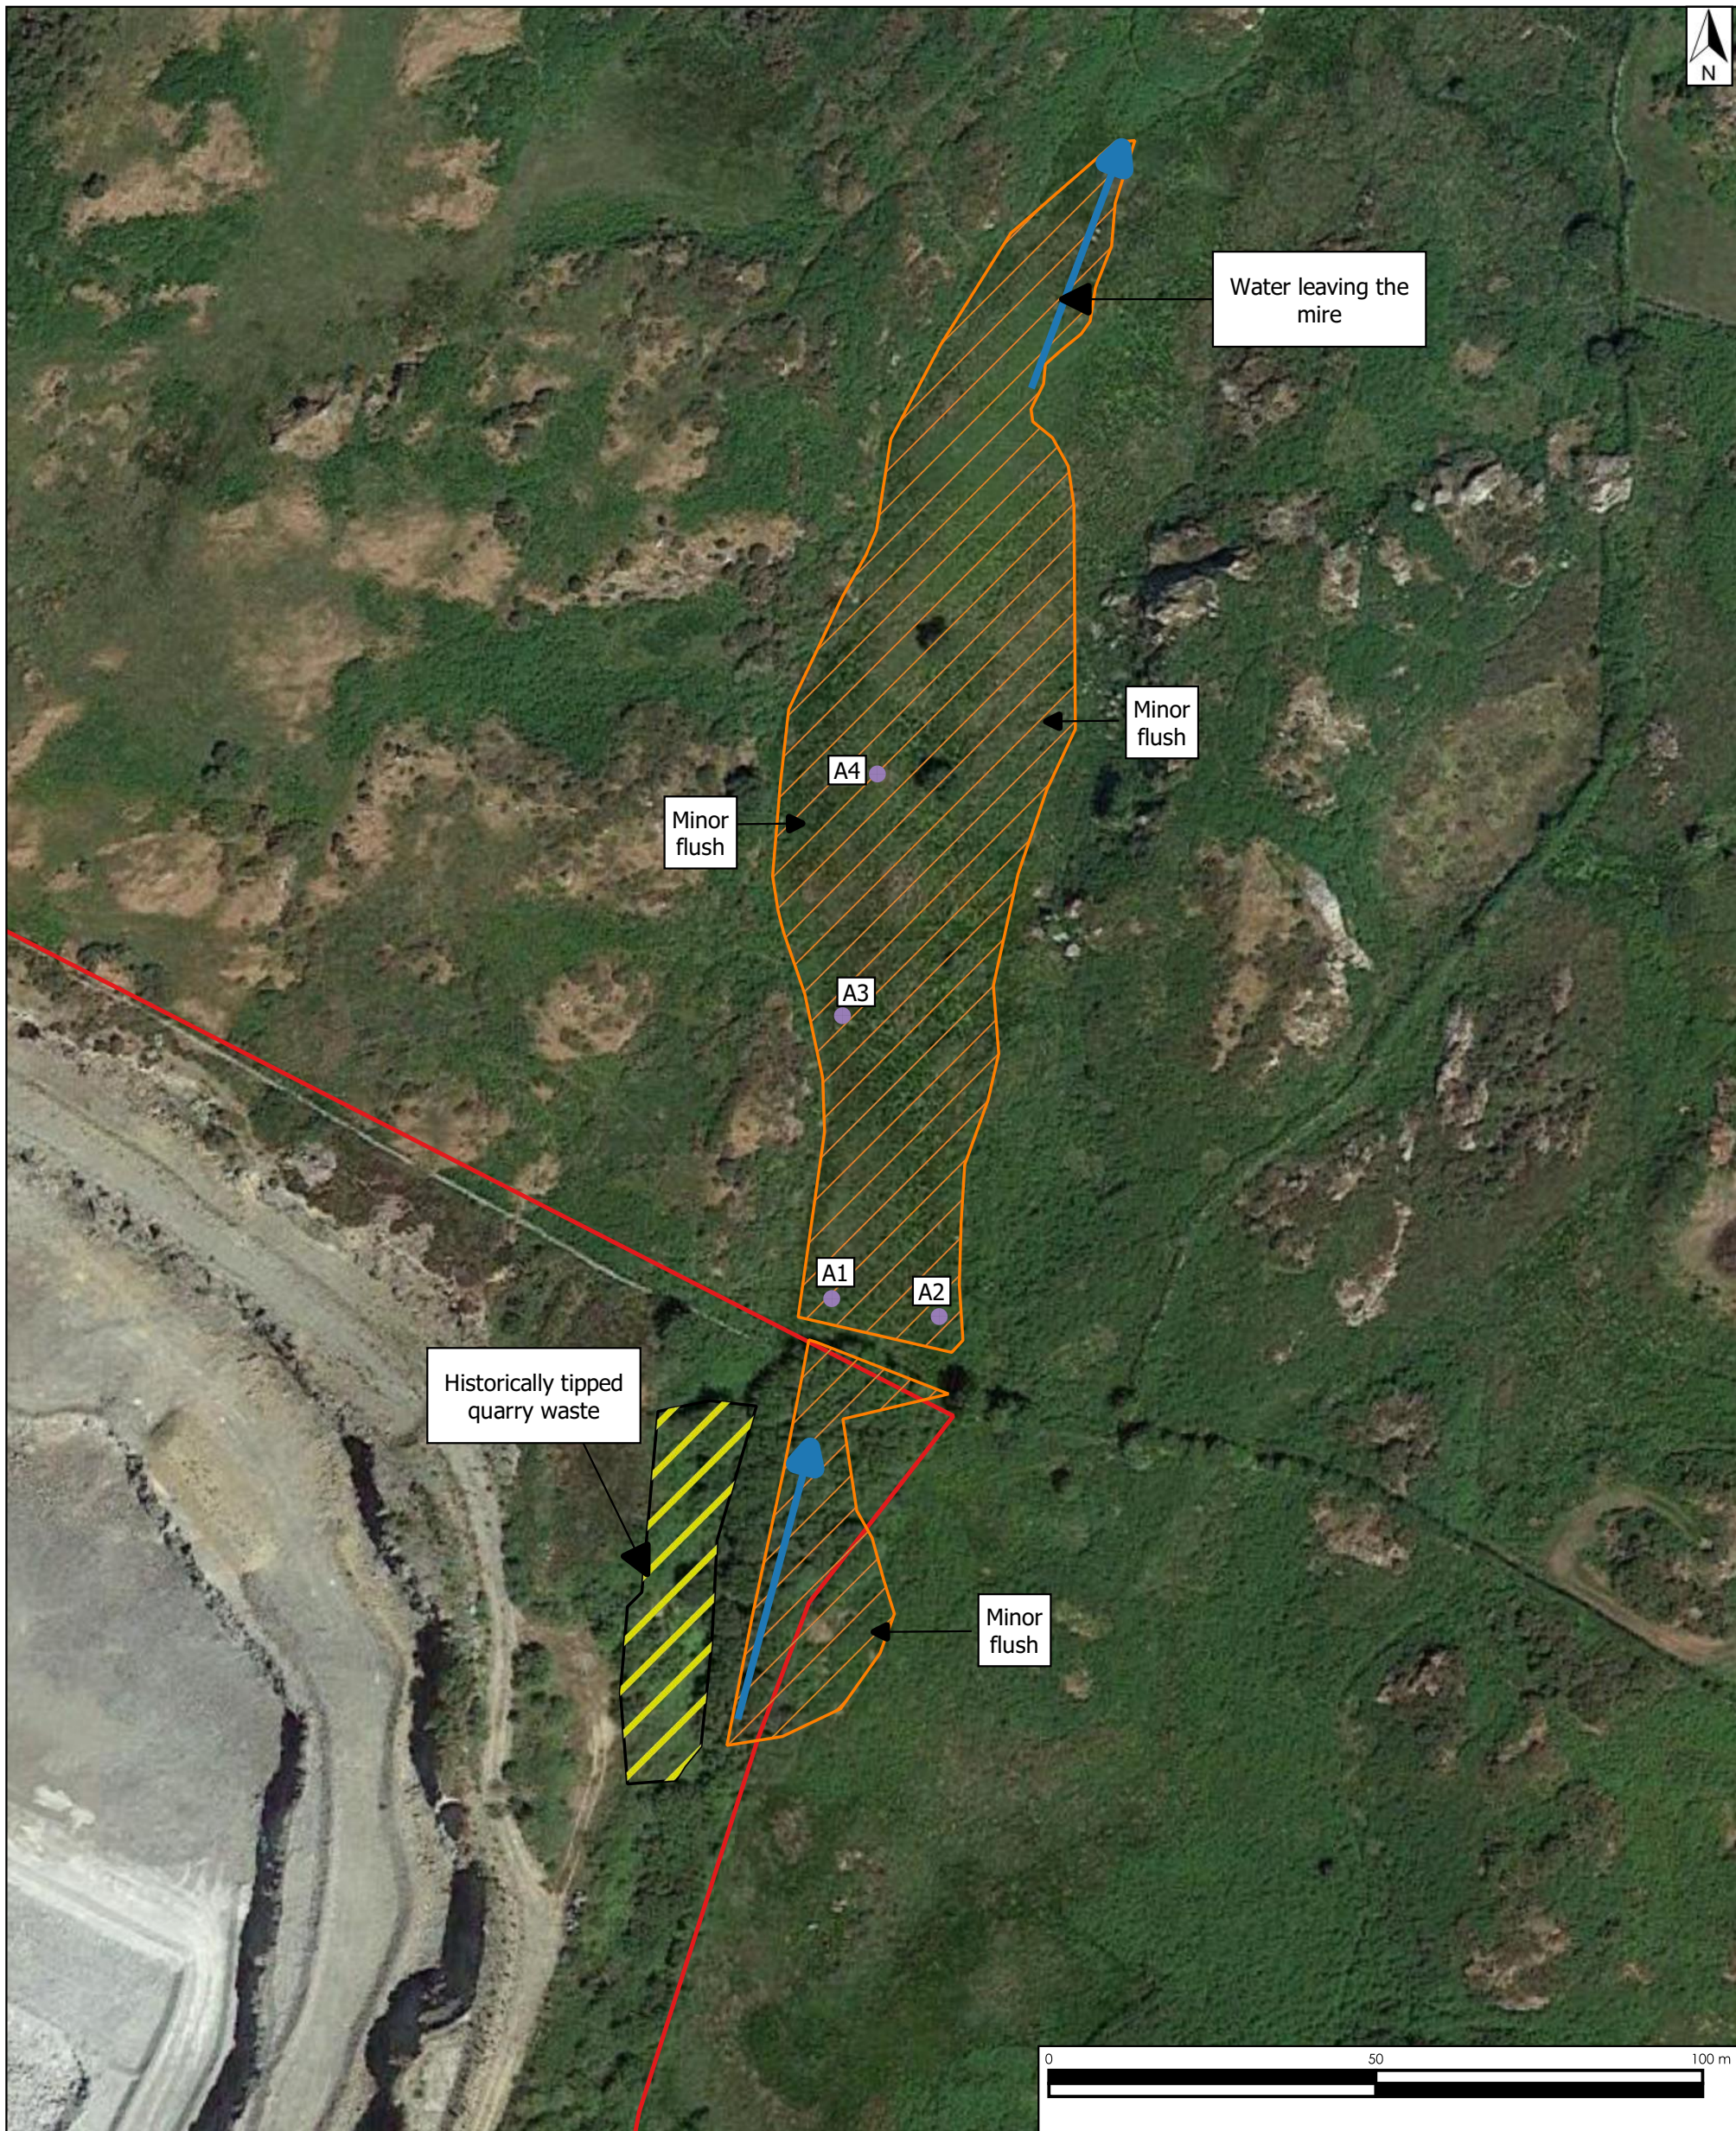
Drawing 3298/HLA/05

- Historically tipped quarry waste
- Valley Mire
- Auger holes
- Existing site boundary

The sub-surface characteristics of the valley mire area were investigated by a targeted shallow augering survey. Four auger tests were undertaken; their locations are shown on *Drawing 3298/HLA/05* and the results are summarised below.

3298/HLA/T1: Summary of augering survey		
Augering ID	Depth (m)	Description
A1	0-0.15	Brown, loose, abundant organic material
	0.15-0.35	Dark brown-black, peaty, becoming firmer
	0.35-0.7	Stiff, light-medium clay, sticky, no further progress possible
A2	0-0.2	Brown, loose, abundant vegetation
	0.2-0.5	Dark brown loam, some sand
	0.5	Bedrock
A3	0-0.2	Very wet, abundant organic material
	0.2-0.3	Becoming firmer, black/very dark brown, silty clay
	0.3-0.6	Very stiff, light grey clay, putty-like
A4	0-0.25	Abundant vegetation, loose, dark brown
	0.25-0.35	Dark brown loam
	0.35-0.65	Stiff, light-medium clay, very stiff, stick and putty-like

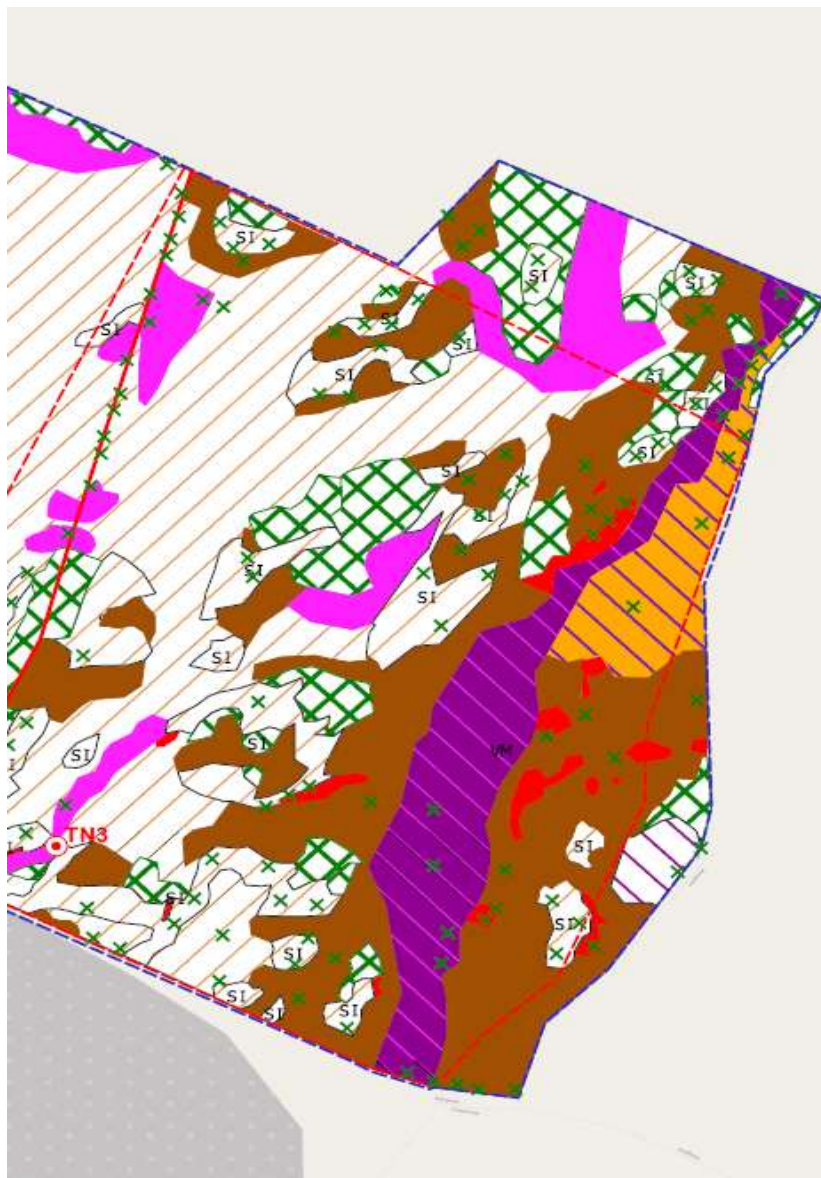
Project	Caer Glaw	
Drawing	3298/HLA/03	Version 1
Date	Mar-22	Scale As Shown

Title Caer Glaw Habitat Plan

The landform in the vicinity of the existing quarry and the valley mire ranges in elevation between 25 and 65 metres Above Ordnance Datum (mAOD). The topography has a pronounced southwest-northeast 'grain', which is a result of the strong influence of the bedrock geology. Although generally subdued, higher areas, with exposed bedrock, exist, which are separated by low-lying, frequently boggy tracts. The vegetation and landform are shown on the aerial imagery, *Drawing 3298/HLA/02* and the ecological designations are shown on *Drawing 3298/HLA/03*.

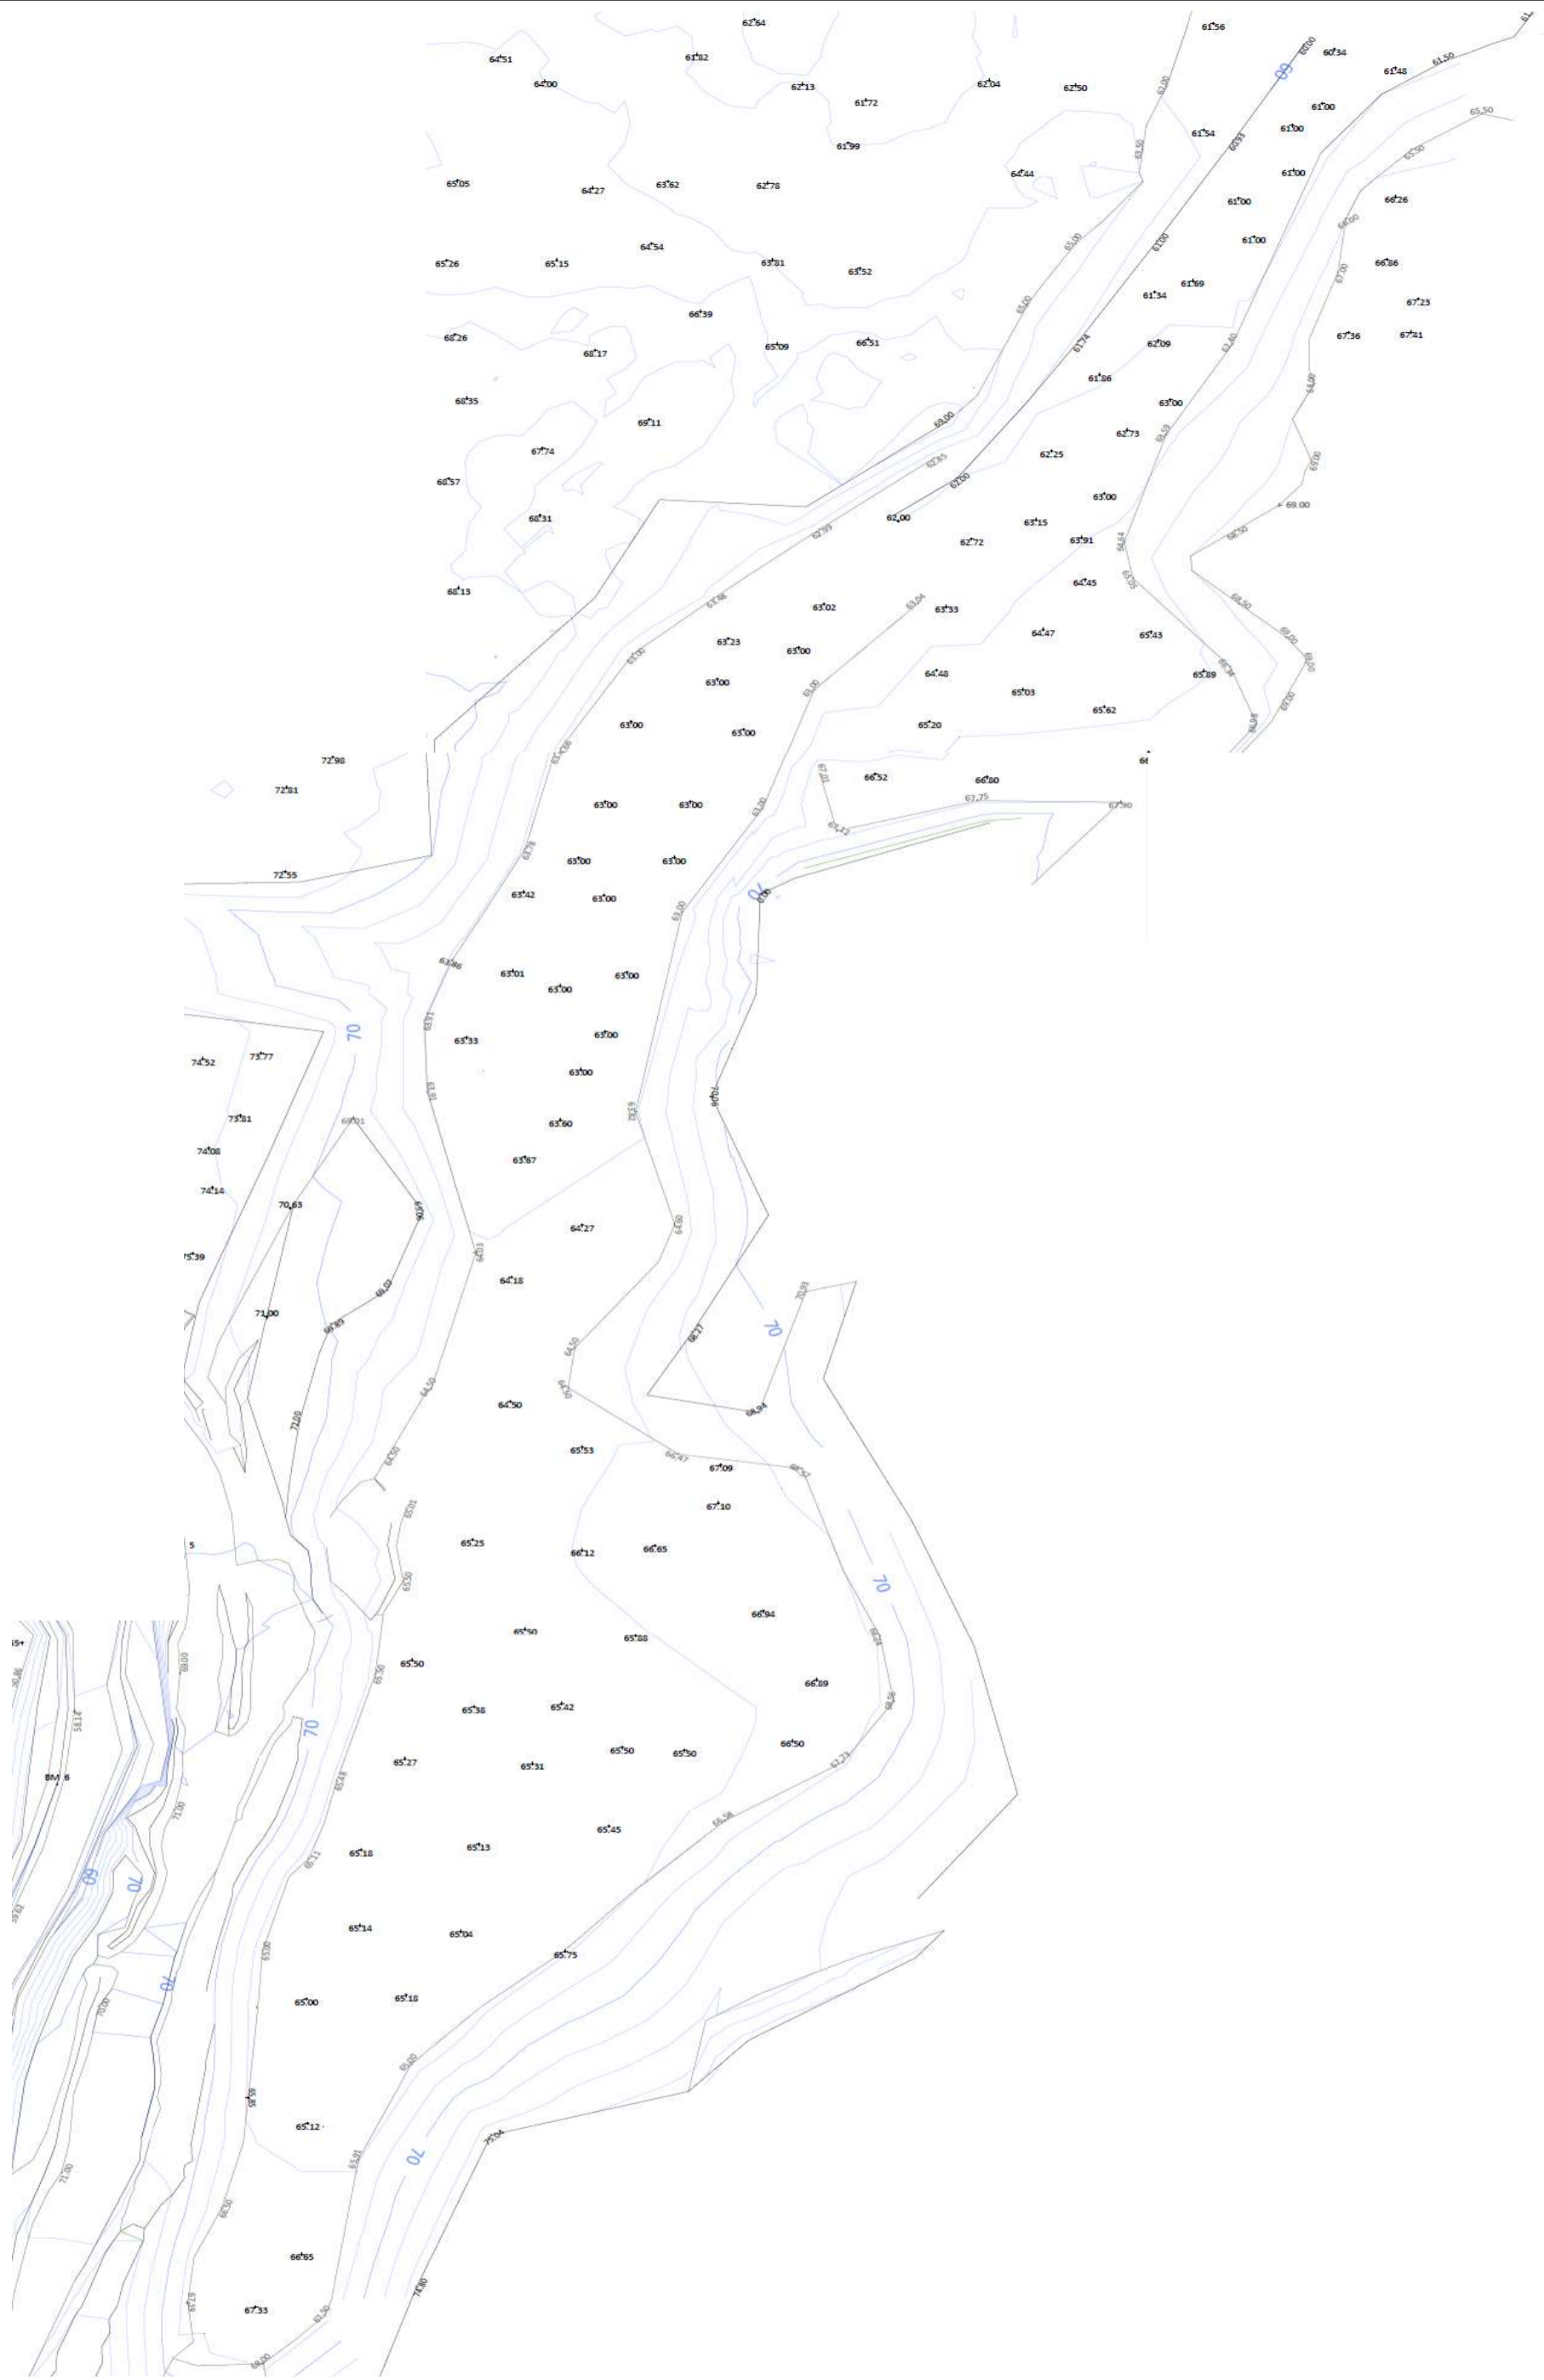
The topography of the valley mire and its margins is shown on *Drawing 3298/HLA/04*.

The floor of the active quarry void is situated at approximately 41 mAOD. The valley mire comprises an elongate, flat-bottomed feature, which decreases in elevation from 67 mAOD at its southern extent, to approximately 62 mAOD at its northern margin. It is located to the east of both the existing quarry and proposed extension. In the vicinity of the quarry the western margins of the southern section of the valley mire abut against historically tipped waste material from the quarry. The valley mire is shown on *Photograph 3298/HLA/P1 (Photosheet PS1)*.

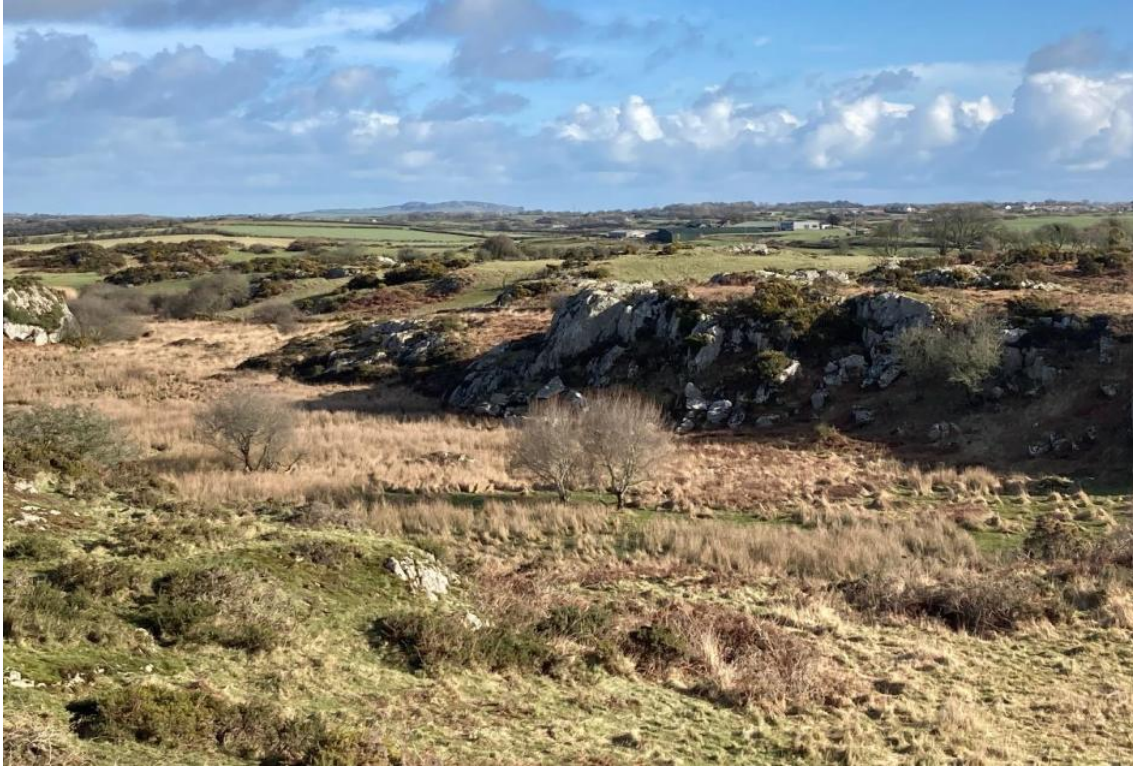
Photograph 3298/HLA/P1: General view of valley mire looking northeast

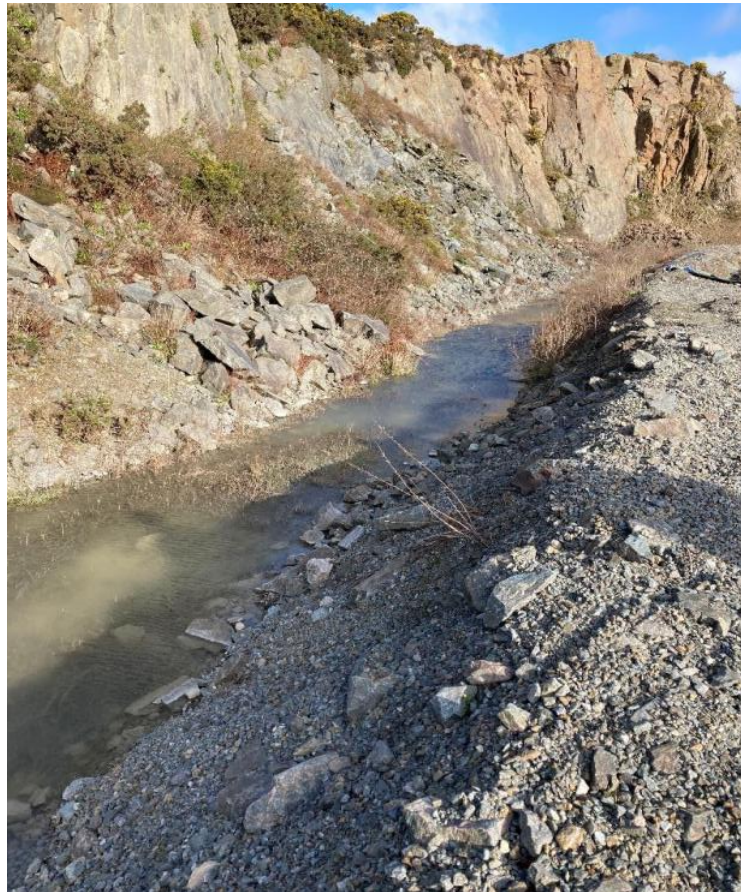
3298/HLA/P2: Water in the floor of the quarry void

The groundwater level within the bedrock can be inferred from observation within the quarry void. Standing water in a ditch/drain located in the west/central section of the quarry void occurs at an elevation of approximately 40 mAOD. This is just below the floor of the quarry void. Water was previously abstracted for use in a mobile crushing plant from a shallow waterbody/ditch. It was reported that water could be drawn from the feature continuously and that it never ran dry. From these observations it can be inferred that the groundwater level within the mass of the bedrock is situated at approximately 40 mAOD (see *Photograph 3298/HLA/P2 (Photosheet PS1)*).

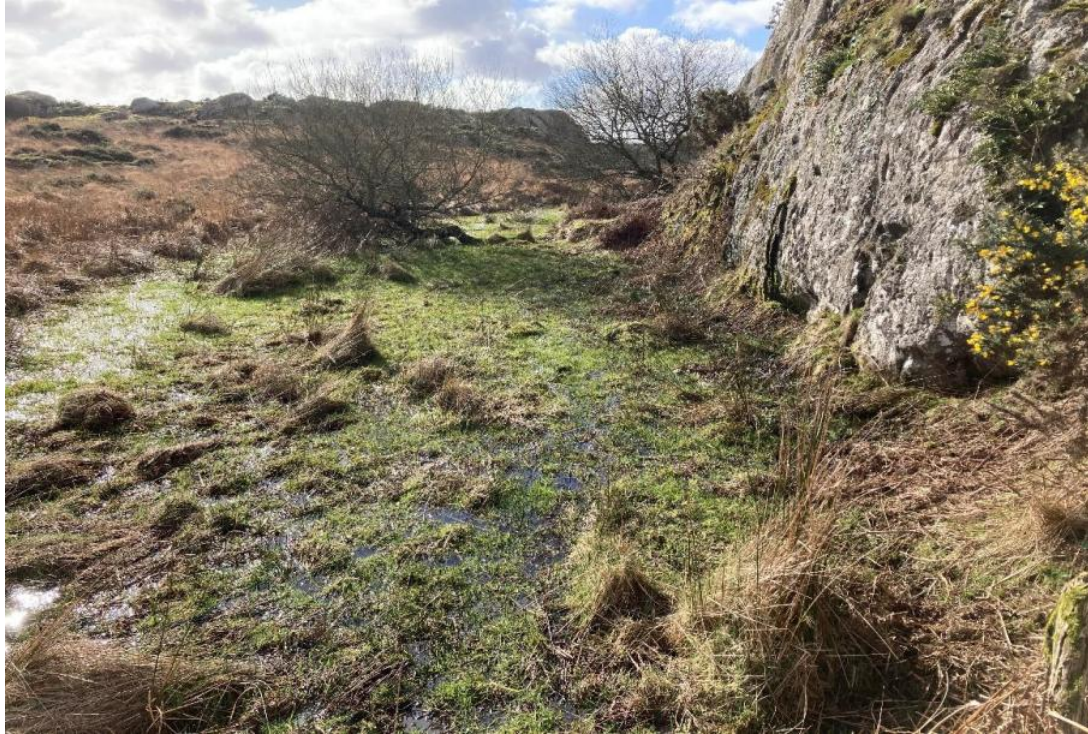
Photograph 3298/HLA/P3: Granite exposed adjacent to waterlogged area

Photographs of the mire, illustrating all the described water features, are shown on *Photographs 3298/HLA/P3 and P4 (Photosheet PS2)*.

The bedrock in the vicinity of the valley mire comprises the Coedana Granite and is the same material as that extracted in the quarry. The granite locally forms topographic highs and is commonly exposed at the surface. The granite flanks the valley mire and is at times exposed immediately adjacent to water-logged areas (see *Photograph 3298/HLA/P4*).

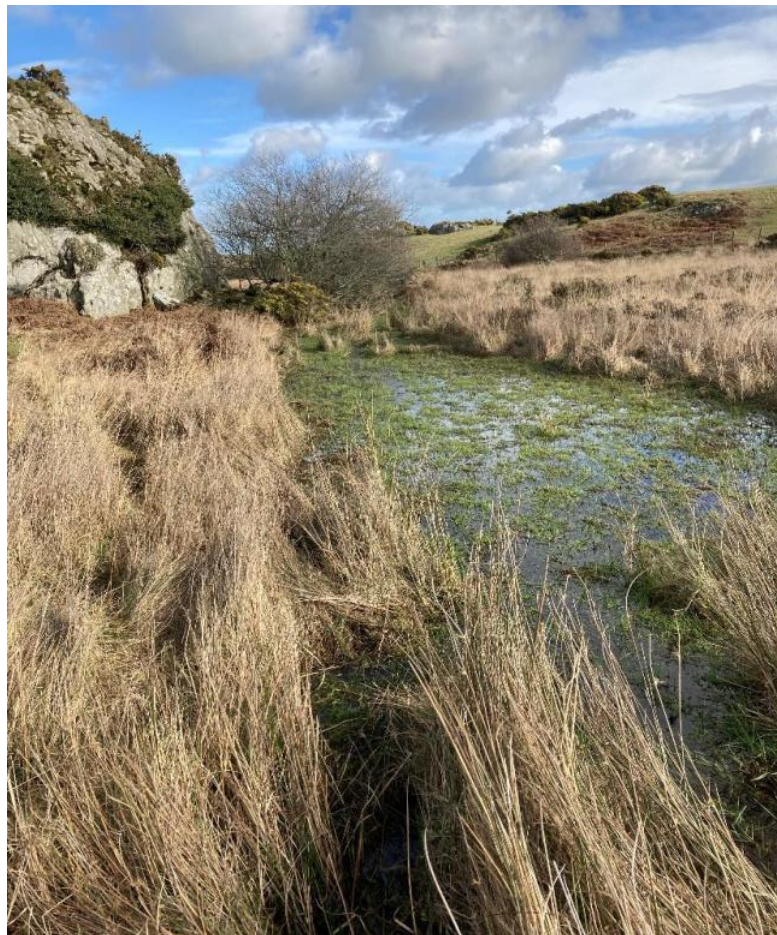
3298/HLA/P4: Outflow of water from north of the mire

The northern section of the mire extends to approximately 0.7 ha and is similarly waterlogged. The mire narrows to its north due to the slight increase in ground elevations, resulting in channelling of flow out of the mire system. The flow in the stream at this area is estimated to be 0.5-1.0 l/s. The lateral margins of the valley mire comprise either exposed granite or small increases in ground elevation.

The overall direction of water movement within the mire is northwards. A stream is located within the southern section of the mire, which supplies water to the northern section. Outflow from the mire occurs in the north of the site, ultimately discharging into the Afon Caradog (see *Photograph 3298/HLA/P4, Photosheet PS2*).

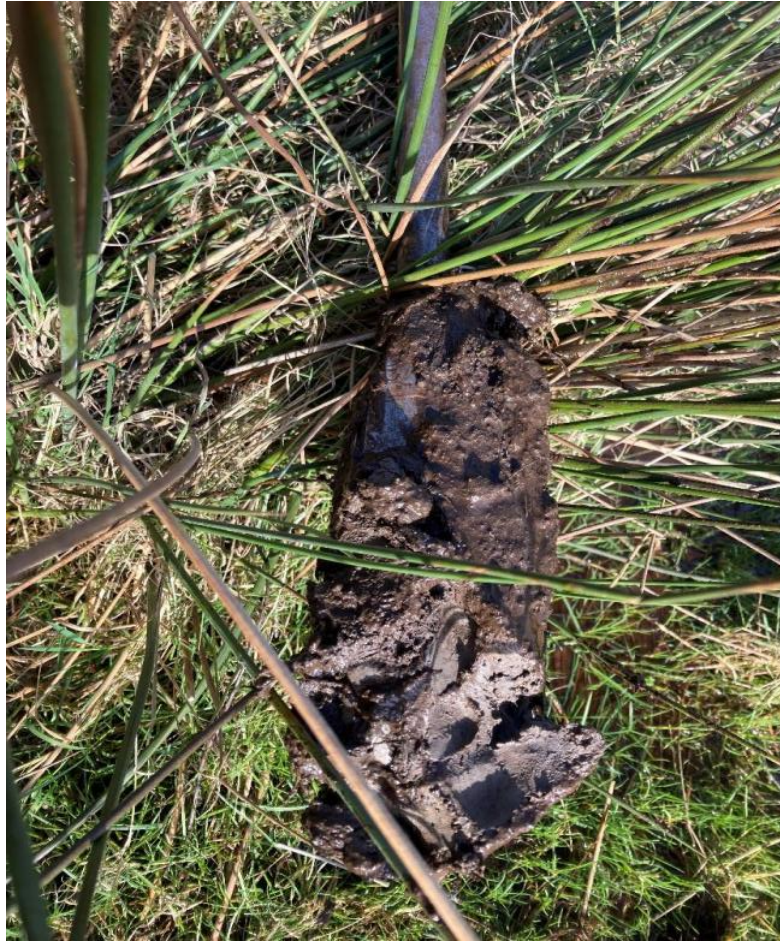
3298/HLA/P5: Auger sample of grey, sticky clay

The nature of the 'basal' clay is shown on *Photograph 3298/HLA/P5 (Photosheet PS3)*.

The assessment has found that the water within the valley mire is supported on a base of grey, firm clay. The clay may be either of glacial or sedimentary origin. The low permeability of the clay has resulted in a perched feature above a substantial thickness of unsaturated granite. The vertical difference between the water within the valley mire and groundwater within the granite is c25 m. It is demonstrated that groundwater within the bedrock and valley mire is hydraulically isolated.
