Job Title: Cae'r Glaw Quarry

Photoview No. 5

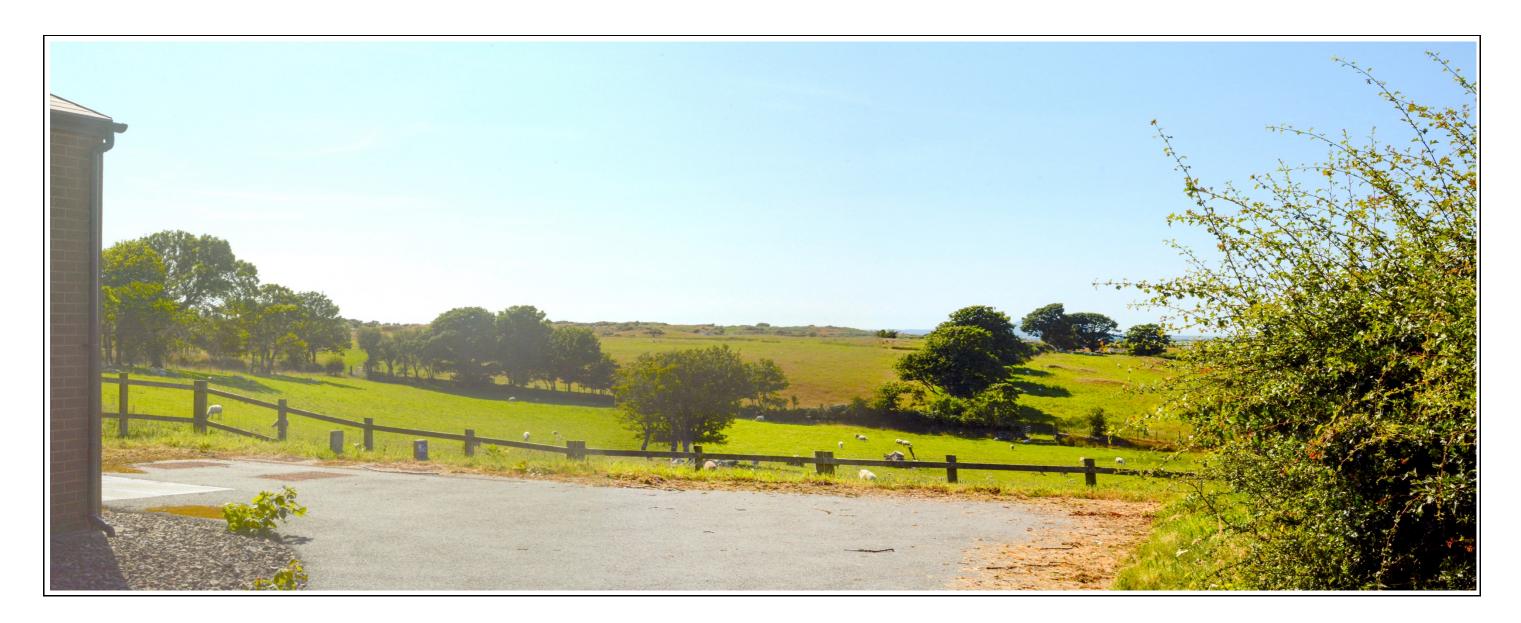
Angle of View: 90° View looking west from unclassified road to the east of the site at Bryn Ala. Classification of Receptor: Highway Distance from boundary: 550m Elevation: 60m AOD Sensitivity: Moderate Edge of building and hard standing associated with Bryn Ala property. Middle Distance Open agricultural land with well established trees forming field boundaries together with hedgerow banks. (cloddiau) Far Distance Agricultural land on the ridgeline.		DESCRIPTION OF VIEW	the quarry extension point. Potential exist machinery during the operation, however	ew, however the ohy will largely screen from this vantage is to see quarry e initial soil stripping this would be seen of the higher land to er term, it may be a sliver of the upper boundary. This uld be only 2/3 would be barely	be restored by overtippin will then be left to regene benches on the western frestoration by means of a soften the edge of the quicompleted, the face will be	ace will be subject to early small restoration blast to arry. Once the blast is be greened utilizing retained arry will be assimilated into	PROPOSE EXTENSION PROPOSE EXTENSION Parc Quarry EXISTING QUARRY Penclegir Bryn-teg Bryn-teg Bryn-teg Gwalchmai Isai Vir-argae Hafod Spring EXISTING QUARRY Penclegir Bryn-teg Gwalchmai Isai Gwalchmai Isai Gwalchmai

EXISTING QUARRY	EXTENSION	EXISTING QUARRY	EXTENSION	
		MAGNITUDE OF IMPACT	Negligible	Moderate	Negligible	Low	
			EXISTING QUARRY	EXTENSION	EXISTING QUARRY	EXTENSION	GRID REFERENCE
		SIGNIFICANCE	Nil	Low Adverse	Nil	Negligible to Slight Beneficial	391773
		OF IMPACT					house associates
